## PHASE 1 INSPECTION REPORT NATIONAL DAM SAFETY PROGRAM

14. MONITORING AGENCY NAME & ADDRESS (if different from Controlling Office) National Dam Safety Program. Stubblefield Lake Dam (MO 30363), Mississippi - Kaskaskia - St. Louis River Basin, Crawford County, Missouri.		12. REPORT DATE December 1980

SUBJECT: Stubblefield Lake Dam Phase I Inspection Report

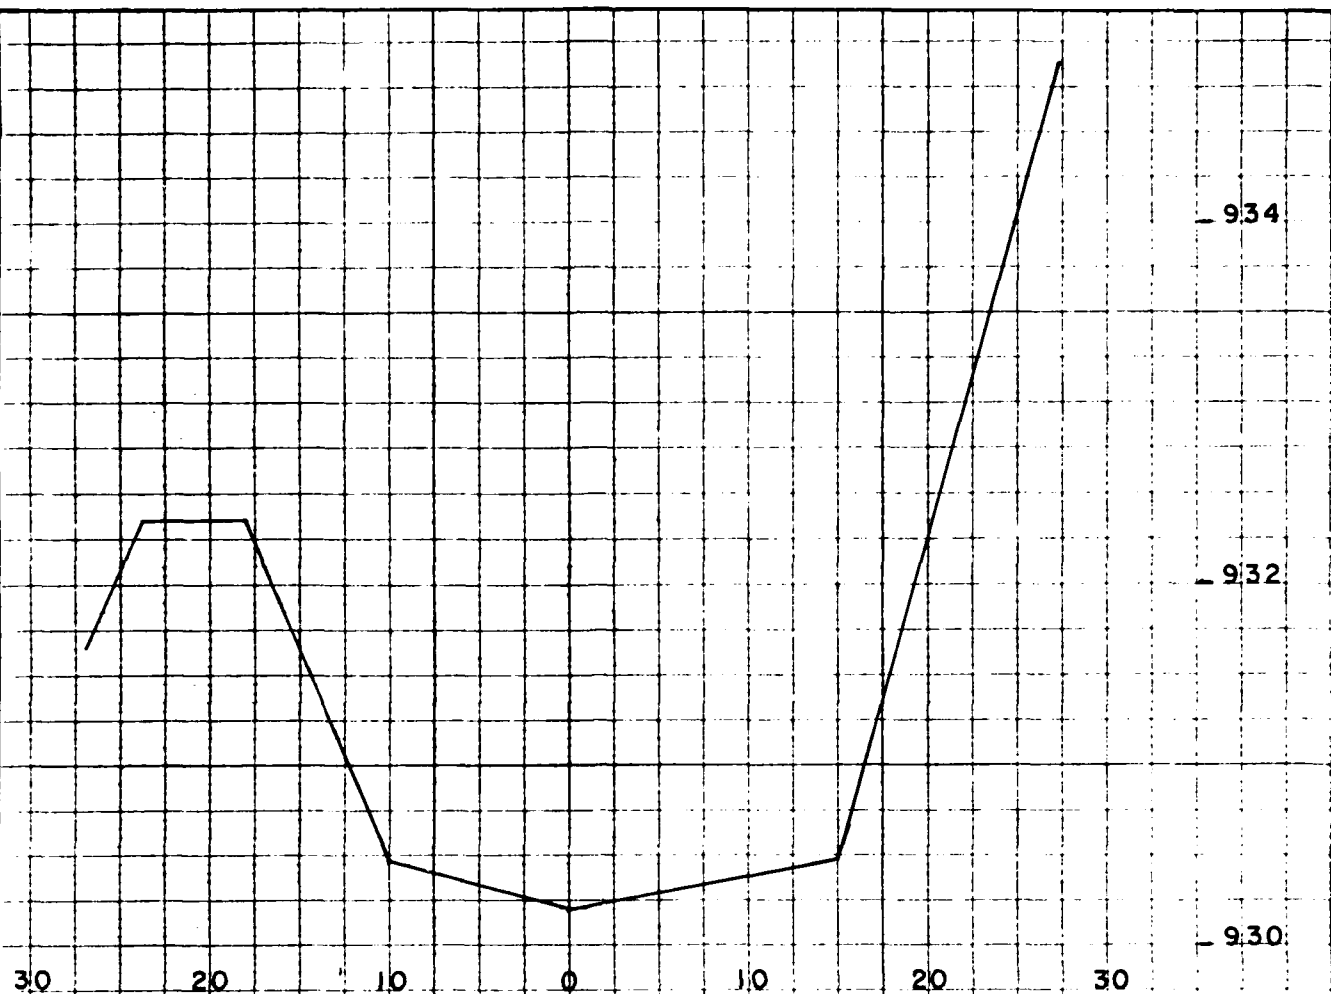
PRINCIPAL SPILLWAY SECTION 39' DOWNSTREAM of DAM

The principal spillway is an earth cut overflow in the right abutment. The spillway outlet channel is channelized for 400 ft by a low earth berm, and outlet flows are well separated from the dam. The crest of the spillway is protected by a 30 ft long by 10 ft wide concrete slab. The approach area and outlet area are clear (see Photos 9, 10, and 11). The concrete slab is in good condition.
